# LJP Daily Insights for December 16, 2015

## Waikoloa Beach Villas Selective Remedial Repairs

### Current Visit

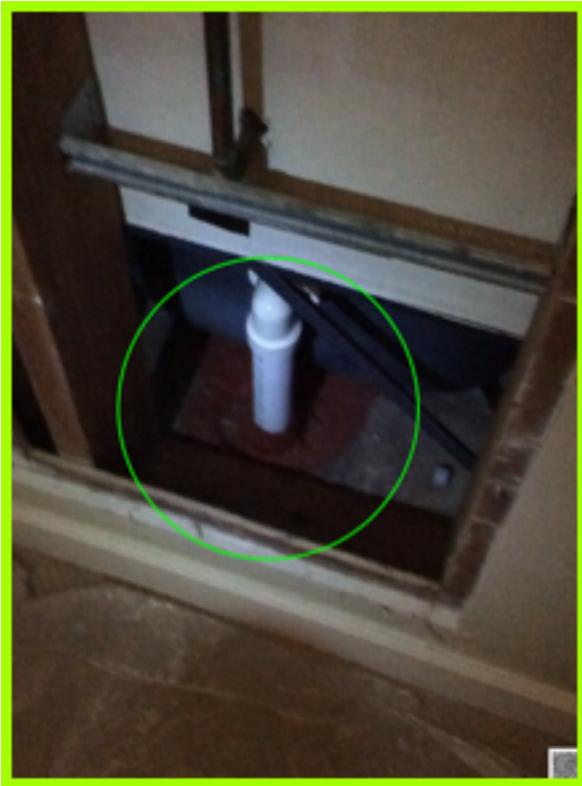
- **Date:** 12/16/2015 02:41 PM
- **Filename:** MFA\_15-3016\_56207ac62d7d3682059422f7\_13
- **Building:** K
- **Notes:** Firecaulking in place at floor to floor penetrations.
- **Photo Type:** Completed/In Progress
